NACA RM E54K29

AXIAL-FLOW COMPRESSOR ROTATING-STALL AND ROTOR

BLADE VIBRATION SURVEY

May 23, 1955

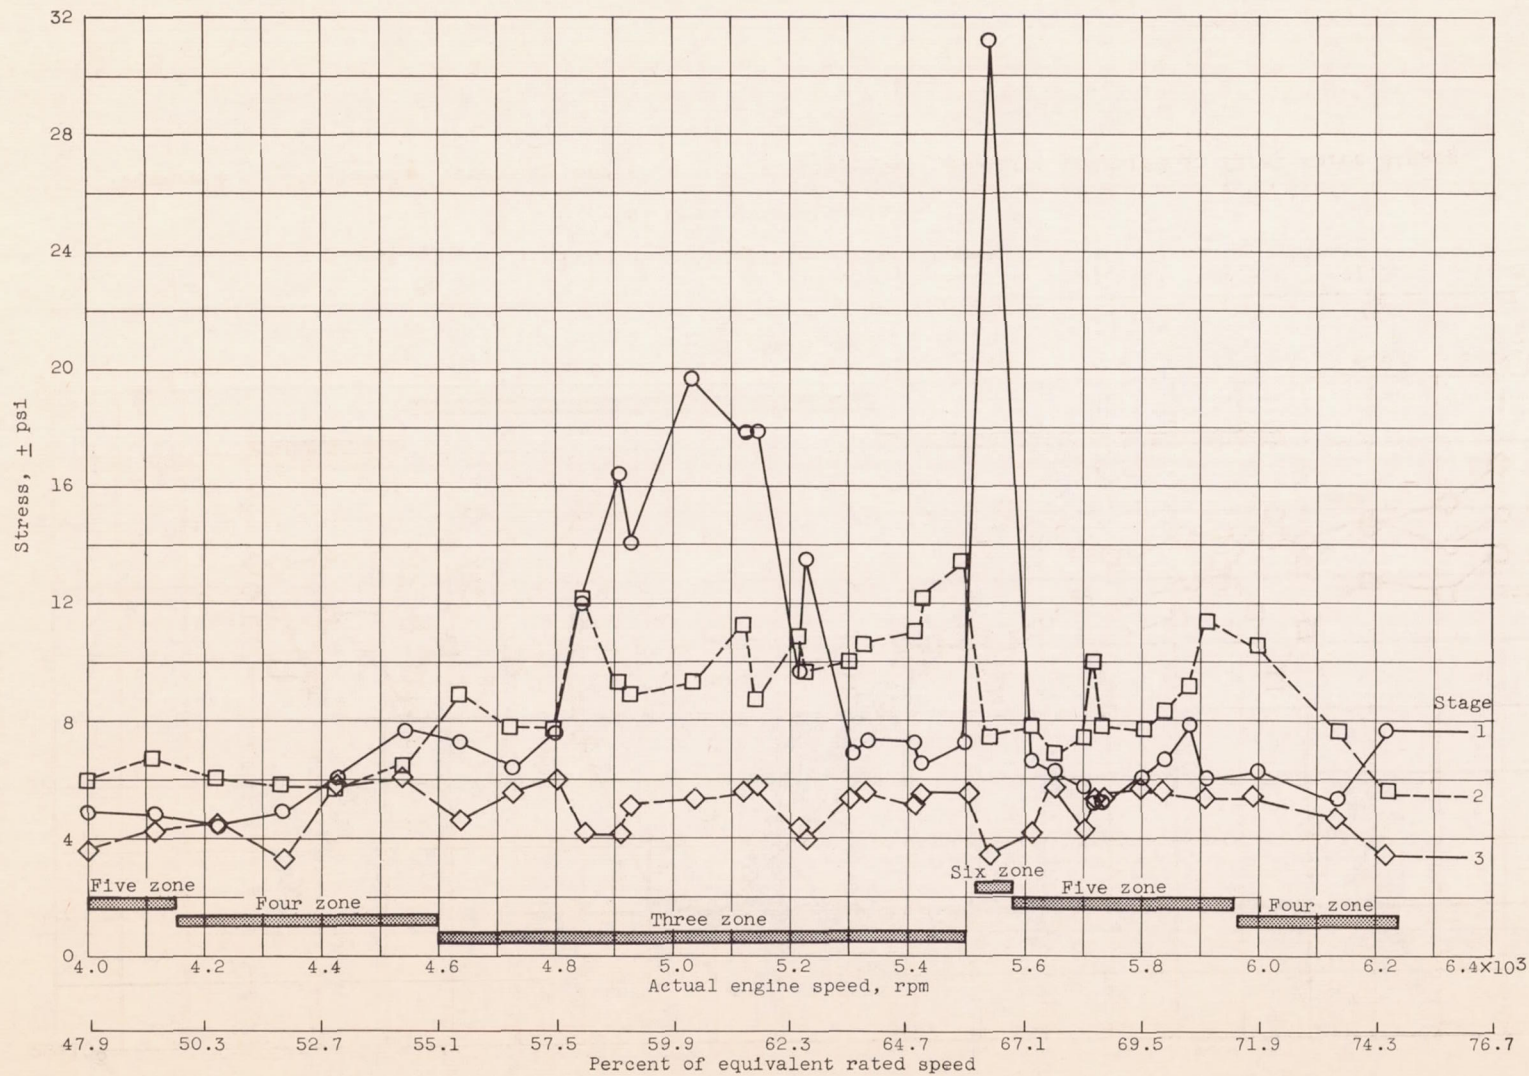
Figure 3. - Vibratory stresses and rotating-stall patterns measured in first three stages.

Figure 3(a) is a plot of vibratory stress against actual engine speed and percent of equivalent rated engine speed. A vibrating blade is affected by the actual speed; therefore, the vibration data will be discussed in terms of actual speed. The percent of equivalent rated speed can be used to locate the rotating-stall data on the performance curve in figure 2(a). Complete compressor data were not obtained for these data points. The data for this figure were obtained with the compressor operating with reduced nozzle area. At the bottom of the curve in figure 3(a) is a bar graph presenting the detailed rotating-stall data. As the compressor speed was increased, the stall-zone sequence was 5, 4, 3, 6, 5, and 4. The three-zone stall was the strongest and persisted over the longest speed range. At approximately 6240 rpm (74.5 percent of rated equivalent speed) the compressor was free of rotating stall.

An examination of figures 3 and 4 indicates that the peak stresses existing at approximately 5000 rpm occurred at the point of intersection of the blade frequency line, and the line representing twice the relative frequency of the three-zone rotating stall. The peak stress of  $\pm 31,200$  pounds per square inch (fig. 3(a)) was excited by a six-zone rotating-stall pattern. This stall pattern was observed over an extremely short speed range.

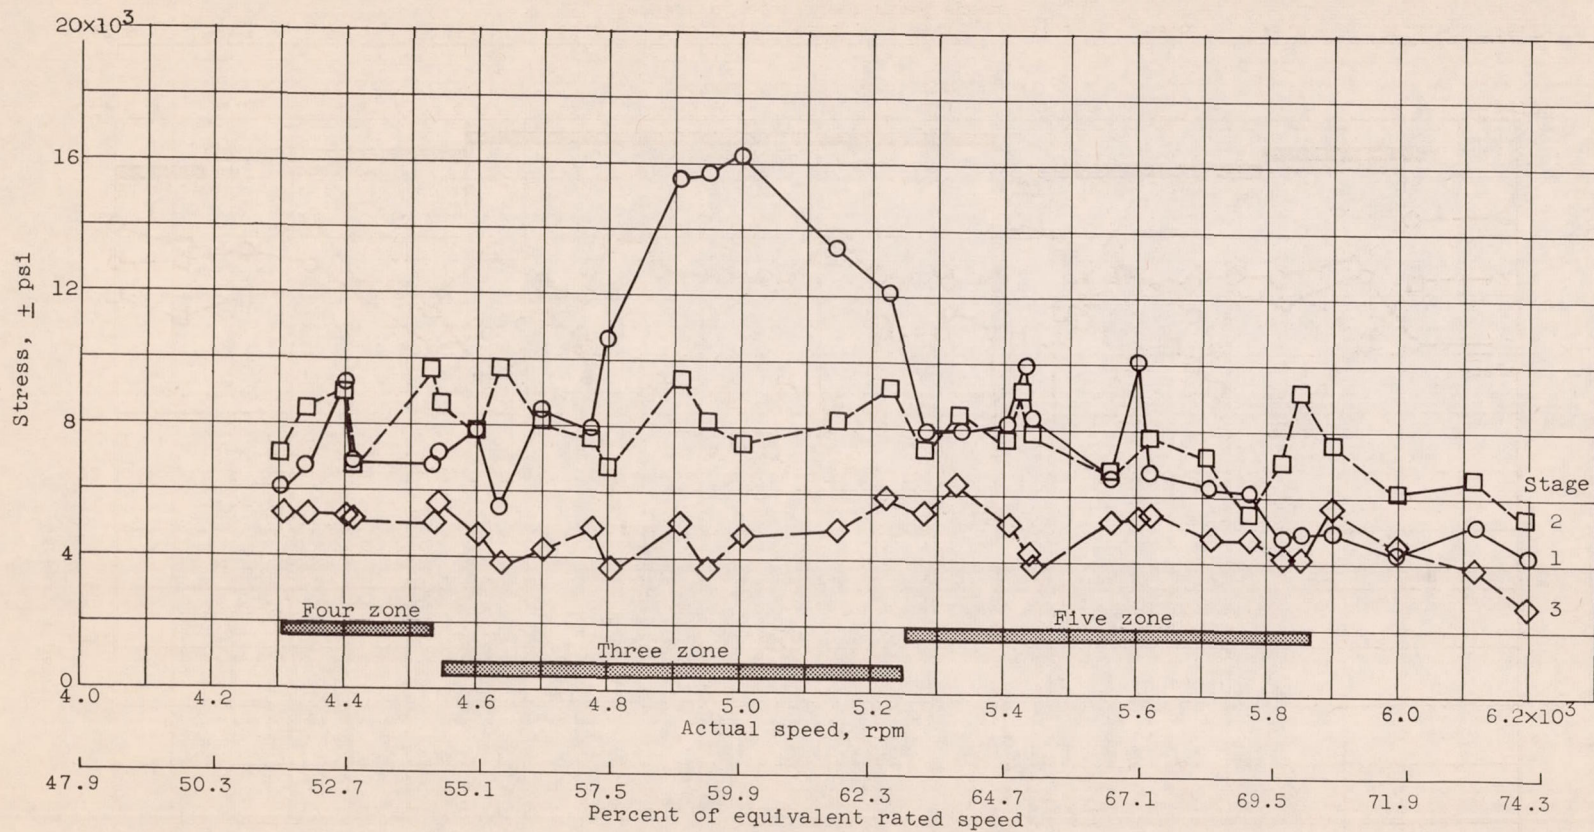
Figure 3. - Concluded. Vibratory stresses and rotating-stall patterns measured in first three stages.

Figure 3(b) is a plot of vibratory stress against actual speed and percent of equivalent rated engine speed. These data were obtained with the compressor operating on the open-nozzle line of figure 2(a). At the bottom of the curve is a bar graph presenting the detailed rotating-stall data. As the speed was increased, the stall zone sequence was 4, 3, and 5. As in figure 3(a), the three-zone pattern was the strongest and persisted over the longest speed range. At approximately 5870 rpm (70 percent of equivalent rated speed) the compressor was free of rotating stall. The operations of the jet engine with the reduced nozzle area or the compressor closer to the stall line increased the severity of the stall, the rotating-stall speed range, and the number of patterns. The six-zone pattern was observed only while operating with the minimum exhaust area.

In figure 3(b), with the compressor operating on the open-nozzle line, the first stage again had a peak stress at approximately 5000 rpm appearing with a three-zone stall. No peak stresses were observed at 5500 rpm because the six-zone stall was not present.

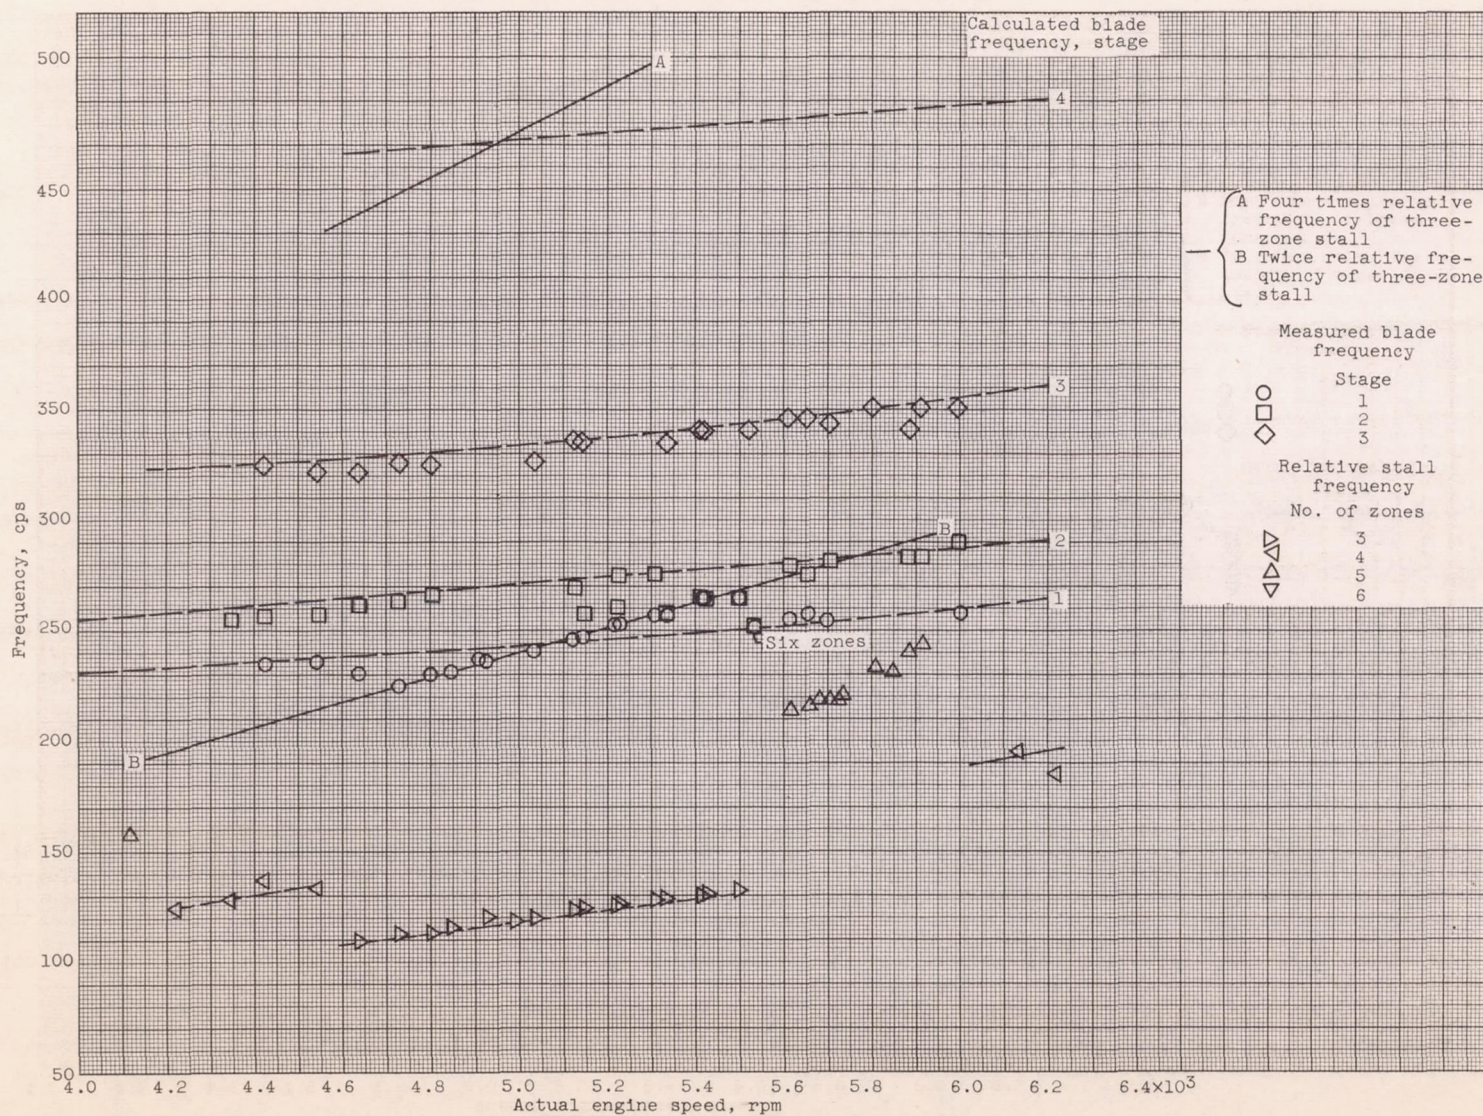
Figure 4. - Rotor-blade and rotating-stall frequencies for 13-stage axial-flow compressor.

Figure 4 is a plot of frequency against "actual" engine speed. The dashed lines represent the natural bending frequencies for the first- to fourth-rotor stages corrected for the effect of centrifugal force (ref. 5). The lower series of data points represents the relative stall frequencies for the three-, four-, five-, and six-zone rotating stall over the range of speeds observed. The frequency of excitation due to rotating stall for a rotor blade is the stall frequency relative to the rotor blades. The relative stall frequency is defined by the following equation:

3561 The upper series of data points represents the actual measured blade vibration frequencies for the first three stages. Over most of the speed range, the blade frequencies followed the dashed lines representing the static frequency corrected for the effect of centrifugal force. However, over the speed range of from approximately 4700 to 5700 rpm, the first-stage blades followed a line "B" representing a frequency equal to twice the relative stall frequency for the three-zone stall. Over a speed range of from 5300 to 6000 rpm, the second-stage blades also followed this two times three-stall line. These first- and second-stage blades were being forced to vibrate by the three-zone rotating stall. In reference 2, the first- and second-stage blades were also forced to vibrate at twice the relative frequency of the three-zone rotating stall and not their own natural frequencies. However, an exception did occur at approximately 5540 rpm (fig. 4). At this point the first- and second-stage blades were forced to vibrate at the frequency of a six-zone rotating stall. Shown in figure 3(a) are the stress data for the first three stages as the compressor was operating on the reduced-nozzle line in figure 2(a). The first stage had peak stress values of  $\pm 19,000$  and  $\pm 31,200$  pounds per square inch at approximately 5050 and 5540 rpm, respectively. The first peak stress was observed with a three-zone stall and the second peak with a six-zone stall. The stresses observed in the second stage were considerably lower than for the first stage. The average stress of the many peaks between 4800 and 6000 rpm was approximately  $\pm 12,000$  pounds per square inch. The three- and five-zone stalls were observed with these vibrations. No stresses over  $\pm 6000$  pounds per square inch were observed in the third stage.

Line A representing a frequency four times the relative stall frequency of a three-zone stall (fig. 4) intersects the fourth-stage blade frequency at approximately 4950 rpm. At this intersection, resonance would occur between the blades and rotating stall. Since strain gages had not been installed on the fourth stage, no blade vibration was recorded; however, it can be assumed that the fourth-stage blades would respond to the three-zone rotating-stall excitation as did the first and second stages (fig. 3).

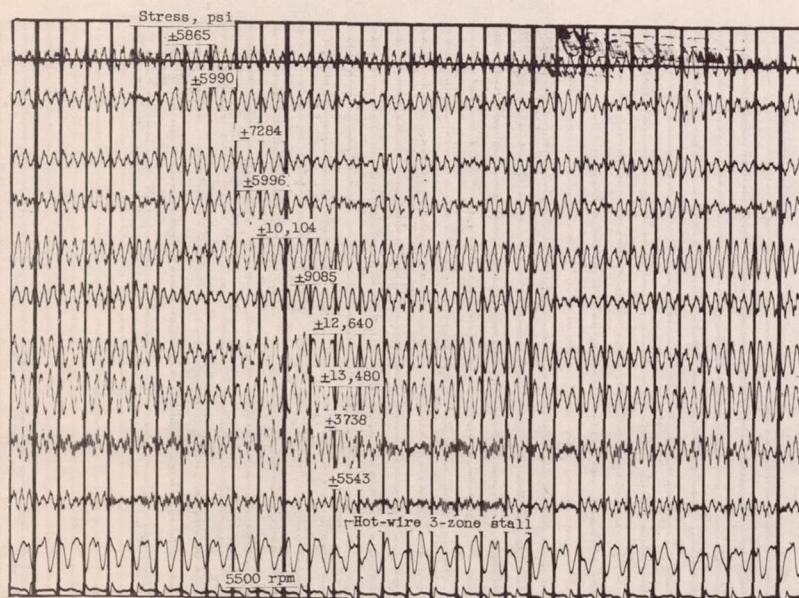
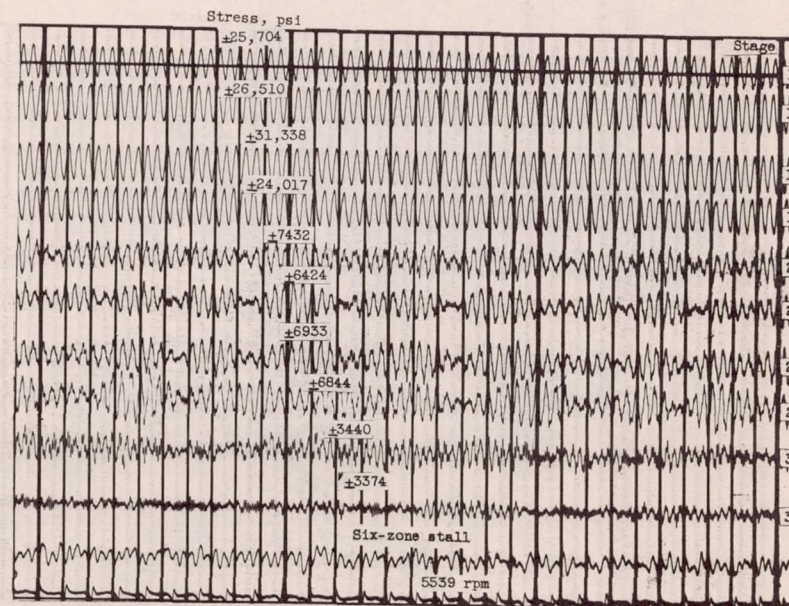
Figure 5. - Oscillograms of vibration caused by rotating stall.

Figure 5 is a reproduction of sections of two oscillograph records. Section A is the record of the blade vibration occurring with a three-zone pattern at 5500 rpm. Here the first-stage blades were vibrating at a low maximum stress of  $\pm 7284$  pounds per square inch. At this compressor speed, the three-zone stall had little effect on the blades, because the relative stall frequency was approximately 15 cycles higher than the natural blade frequency. Section B is a reproduction of the oscillograph record showing the maximum stress recorded in the first stage in this investigation. The compressor speed was 39 rpm higher than that for section A. However, in section B the compressor was operating with six-zone rotating stall. The rotational speed of the six-zone stall was higher than the three-zone stall and, as a result, the relative stall frequency for the six-zone stall was approximately 18 cycles lower than for the two times three stall (fig. 4). This reduction made the relative stall frequency equal to the natural blade frequency. With this fundamental excitation, the exciting forces were high and, as a result, the maximum vibratory stresses were observed.

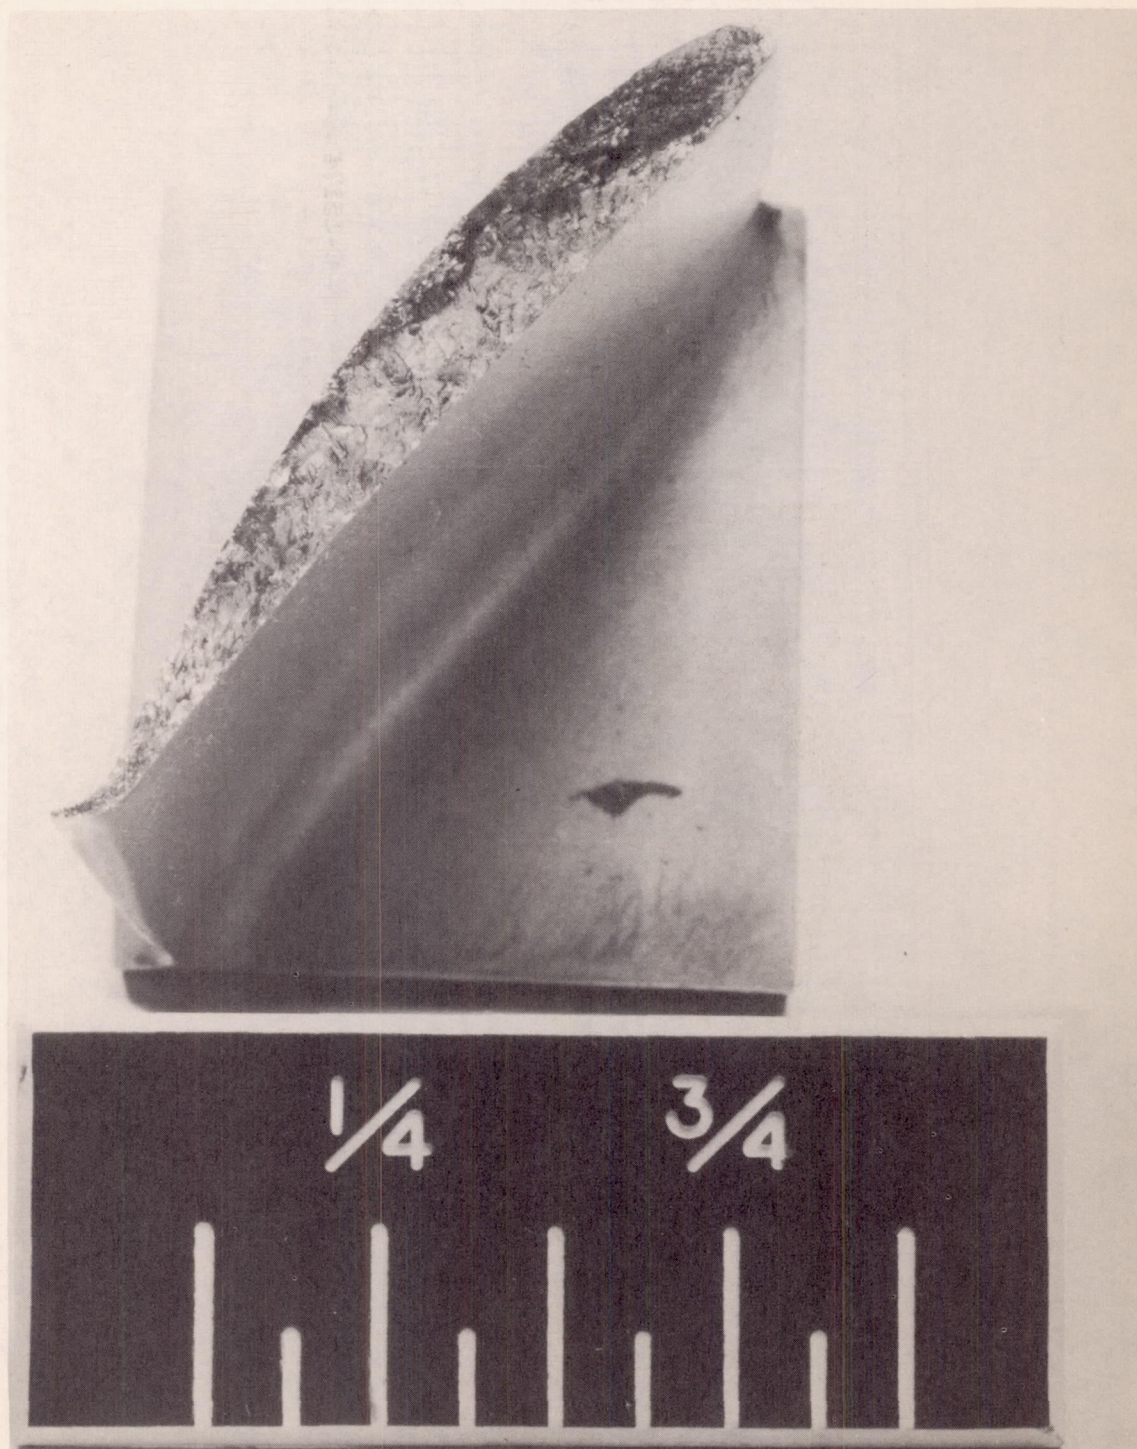
Figure 6. - Failed fourth-stage blade.

After approximately 30 hours of engine operation at various speeds, the compressor case was removed to install additional instrumentation. As the case was removed, it was noticed that about 60 percent of a fourth-stage aluminum rotor blade was missing. The blade section was found wedged in the eleventh-stage stators. Figure 6(a) is a photograph of the failed blade and figure 6(b), a photograph of the fracture surface. An examination of this surface indicated that a fatigue failure had occurred.

4. The investigation was ended by a fourth-stage aluminum rotor-blade failure due to blade vibration excited by a three-zone stall pattern.

(a) Over-all view.

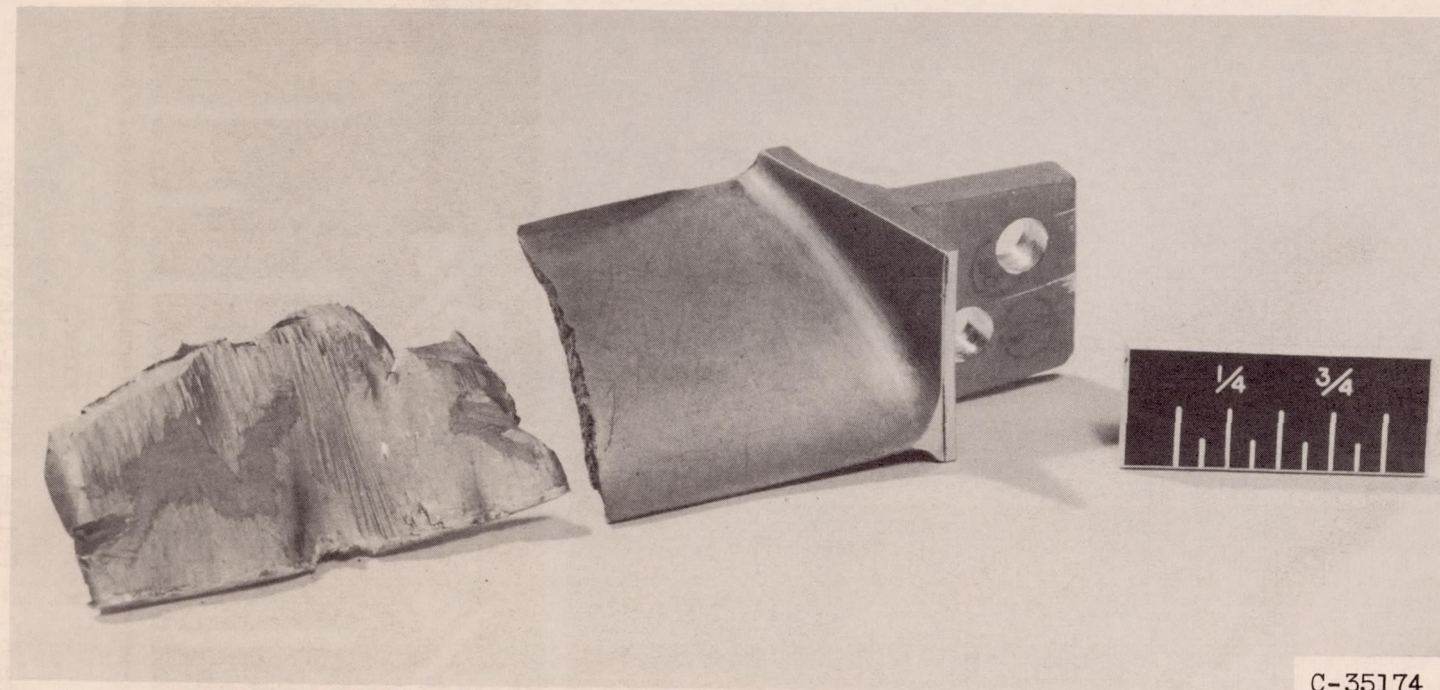
Figure 6. - Concluded. Failed fourth-stage blade.

(b) Fracture surface.
